National Register of Historic Places  
Inventory—Nomination Form

historic Bankard-Gunther Mansion

street & number 2102 E. Baltimore Street not for publication

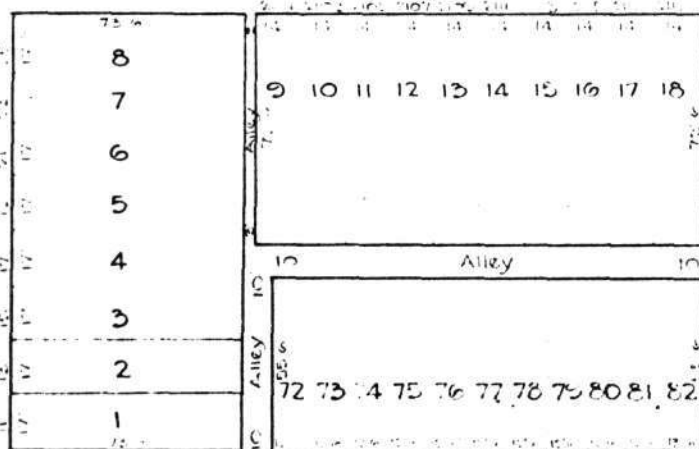
THE BANKARD/GUNTHER MANSION  
2102 E. BALTIMORE ST.  
SITE PLAN

THE BANKARD/GUNTHER MANSION  
IS SURROUNDED BY BRICK  
ROWHOUSES AND IS TWO BLOCKS  
WEST OF PATTERSON PARK.

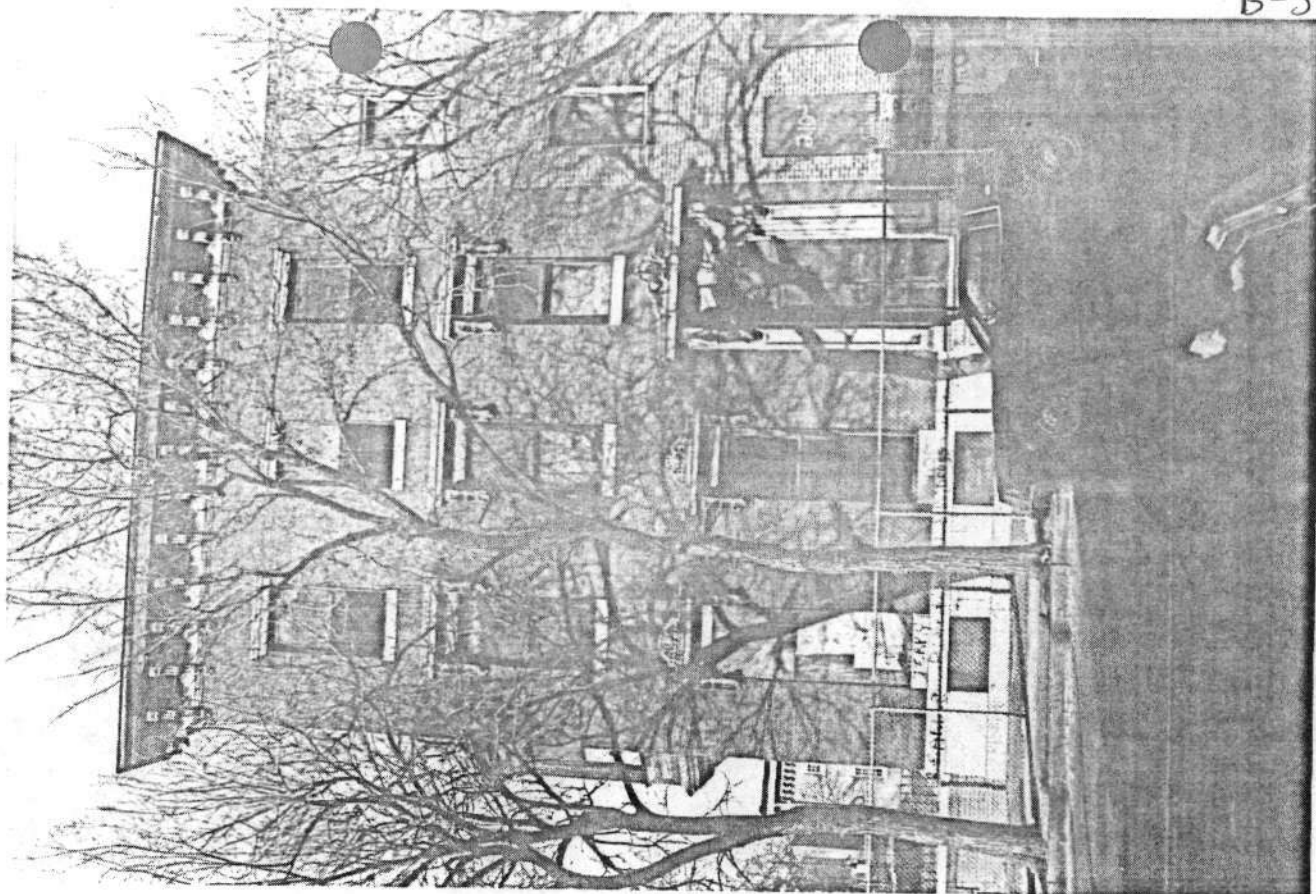
The facade rises up from a smooth stone base which has two windows that open into the basement. The elegantly curved marble stoop at one time had five steps; at present they are severely deteriorated. The stoop extends into the entrance portico which has recessed pilasters and a massive, flat hood above oversized consoles. A large cartouche between ornate scrolls decorates the center of the hood. The round, compound arch beneath the hood is embellished by a rounded keystone. The double doors have four molded panels and a fanlight. Typical of Italianate design, are the two, tall thin first floor windows. They are of one over one construction, feature thick stone sills, are recessed into the wall and are embellished by a scaled down version of the hood covering the entrance portico.

BANKARD/GUNTHER MANSION  
Baltimore City, Maryland  
Jeff Jerome  
December, 1979  
Commission for Historic and  
Architectural Preservation  
Facade, Baltimore Street

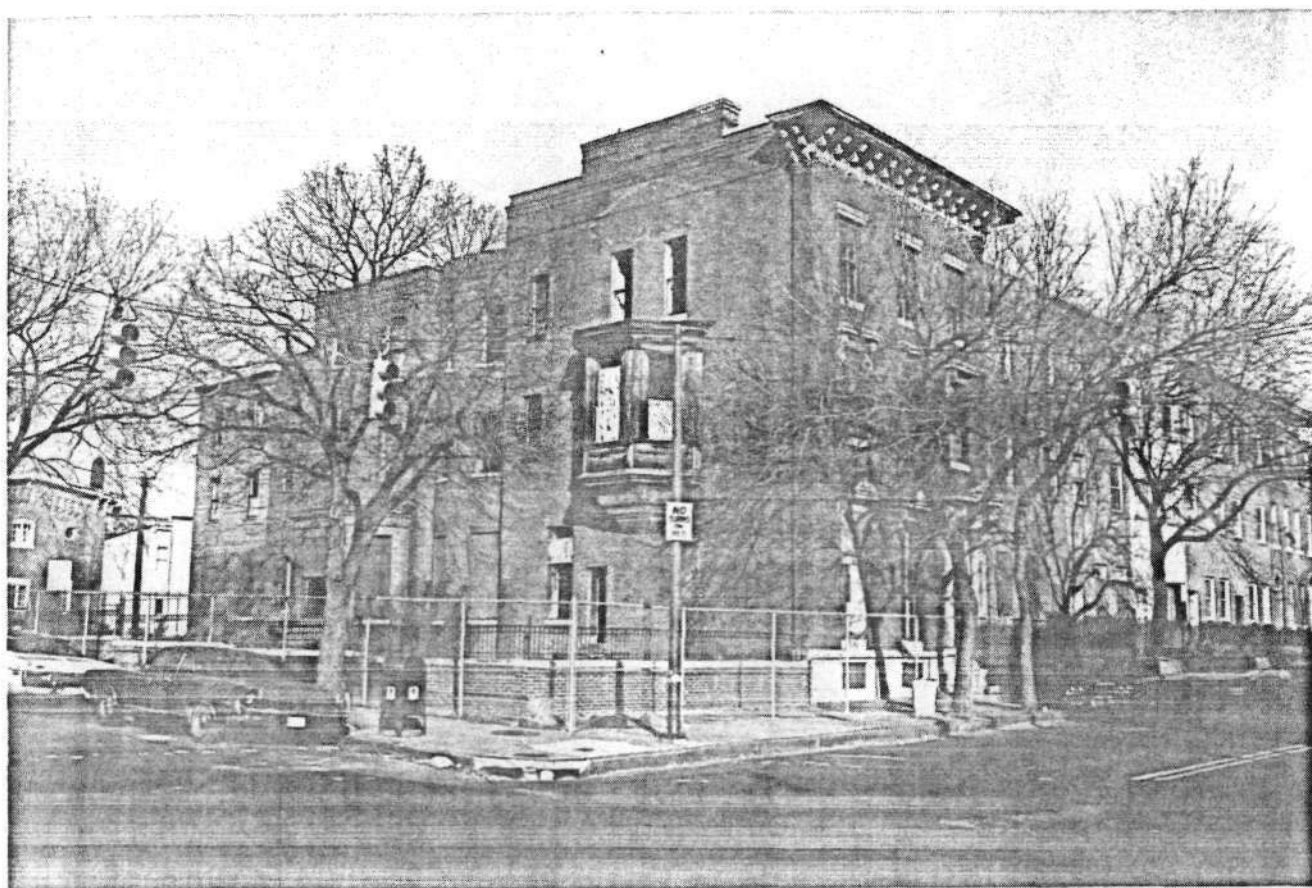
ANKARD/GUNTHER MANSION  
altimore City, Maryland  
eff Jerome  
ecember, 1979  
ommission for Historic and  
Architectural Preservation  
outheast corner,  
altimore and Chester Streets

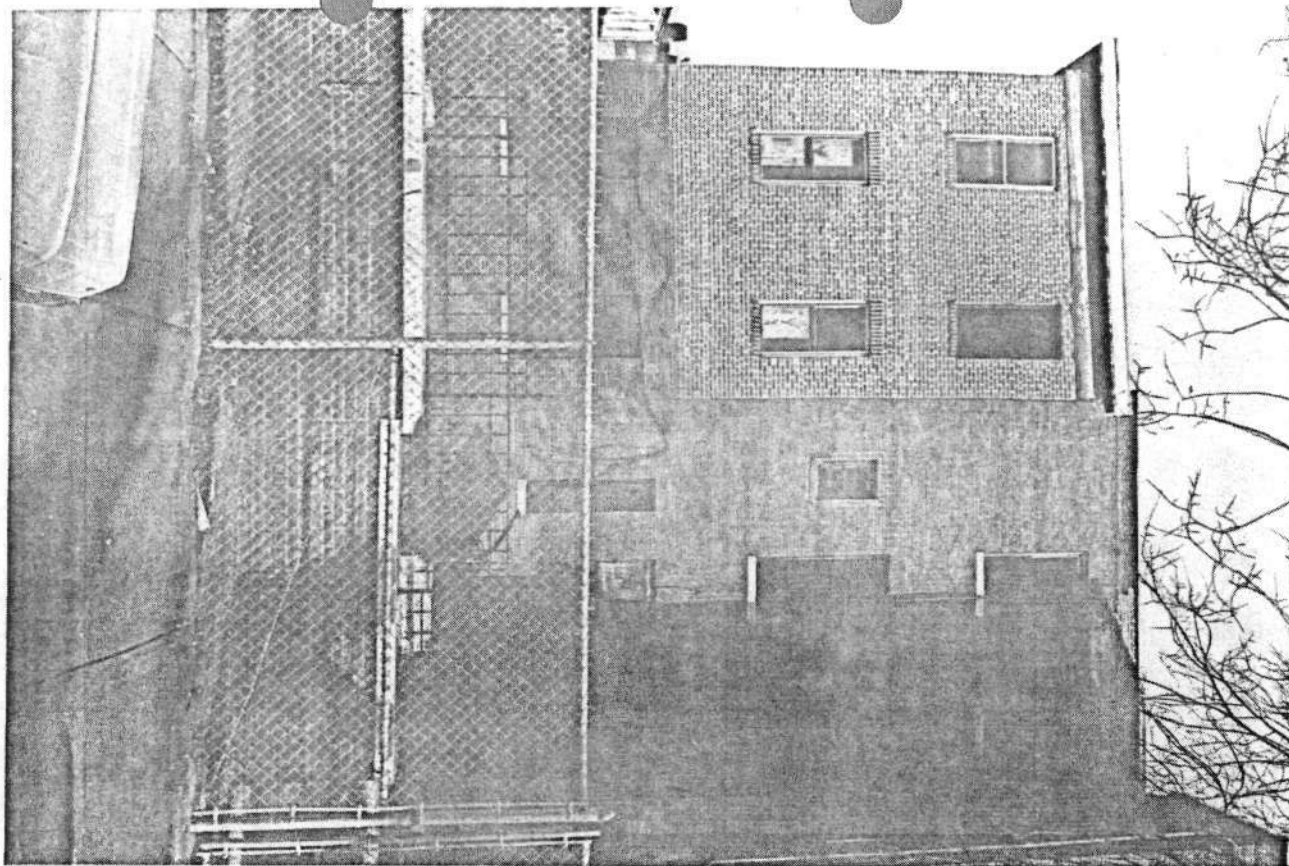
The back of the building, like the last unit of the west side, reveals original and later construction. The first story, at one time located beneath the porch, has two boarded windows of the same early design. The newer section has one window on the left side of both the second and third stories; they are of the same design as those on the "new" west side. The east side of the building is continuous brick with a chimney at its center, it extends to meet the wall of the adjacent building. The mansion is surrounded by a brick and iron fence.

4  
3/12  
BANKARD/GUNTHER MANSION  
Baltimore City, Maryland  
Jeff Jerome  
December, 1979  
Commission for Historic and  
Architectural Preservation  
West side of rear of building

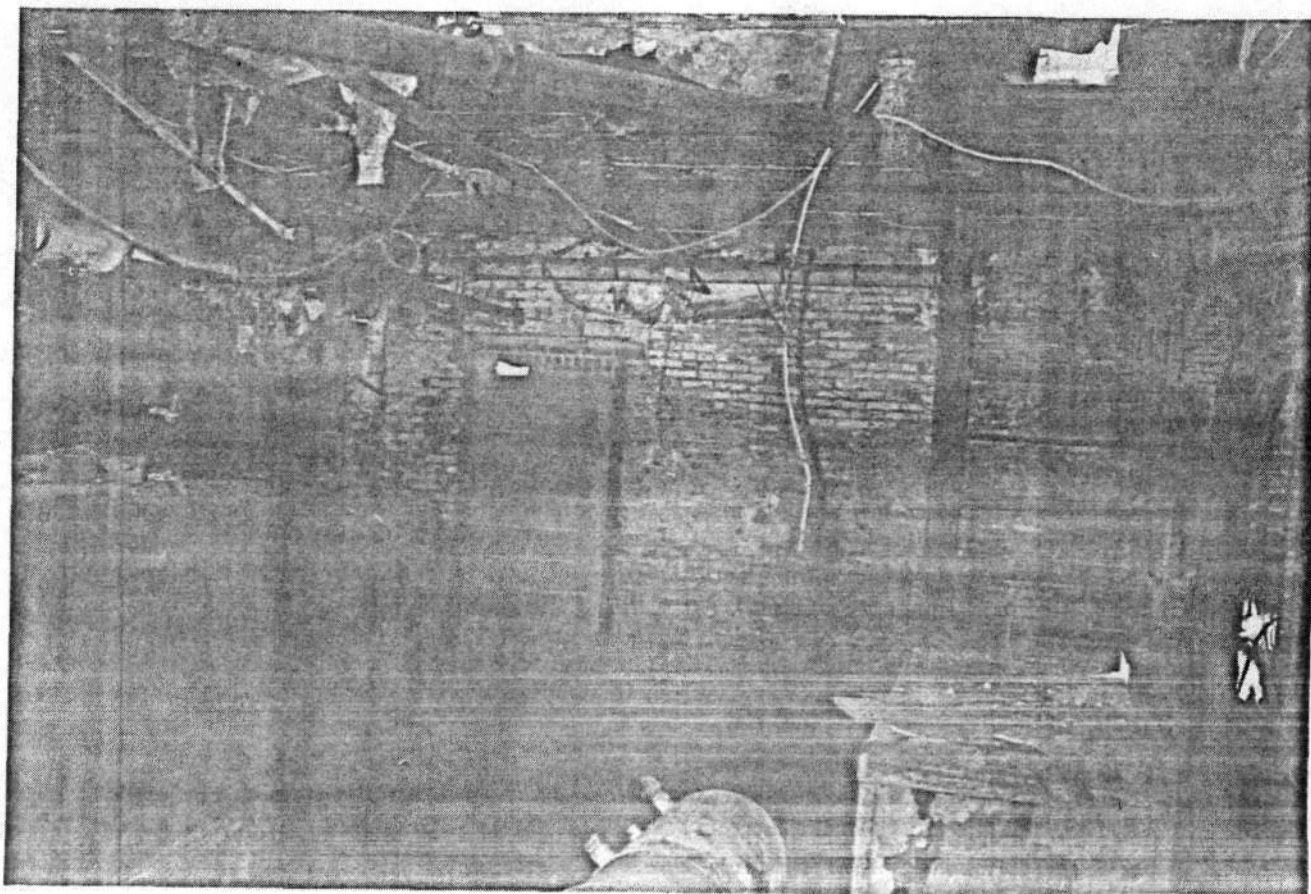
The interior of the building was extensively altered in this century and sections of the upper front floors are unaccessible because of deterioration. The basement is entered from the stairs at the end of the front hallway. While much of it is unexcavated, that portion in the front of the house still contains plumbing and heating fixtures. Many passages have been sealed with concrete blocks; however, two original cooling cellars (exact function unknown) can be easily examined. The brick vaulting is of English bond and is strikingly similar in construction to that found in the vaults of Westminster Presbyterian Church in Baltimore.

BANKARD/GUNTHER MANSION  
Baltimore City, Maryland  
Jeff Jerome  
December, 1979  
Commission for Historic and  
Architectural Preservation  
Basement: note arched entrance  
to cellar at the right

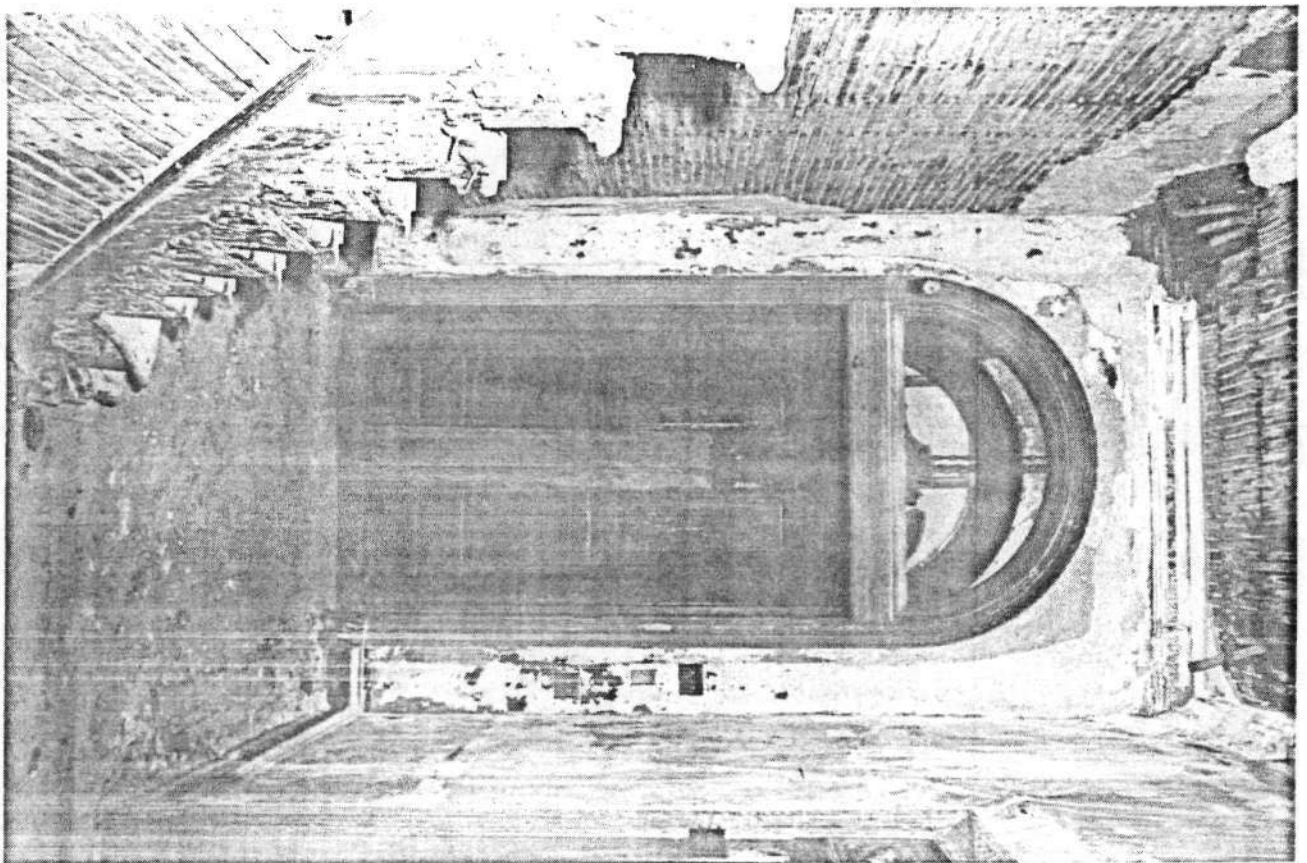
Behind the main entrance is a small vestibule with an arched, transom doorway that opens into the hall. Original appearance of this thickly, molded opening is not known. The original wooden staircase still remains in the hall; however, it is in poor condition and is non-functioning, since the upper stairs meet the concrete block sealing. The open side of the staircase is decorated with elaborately carved scrollwork of particular beauty.

10  
5/12  
BANKARD/GUNTHER MANSION  
Baltimore City, Maryland  
Jeff Jerome  
December, 1979  
Commission for Historic and  
Architectural Preservation  
Main staircase

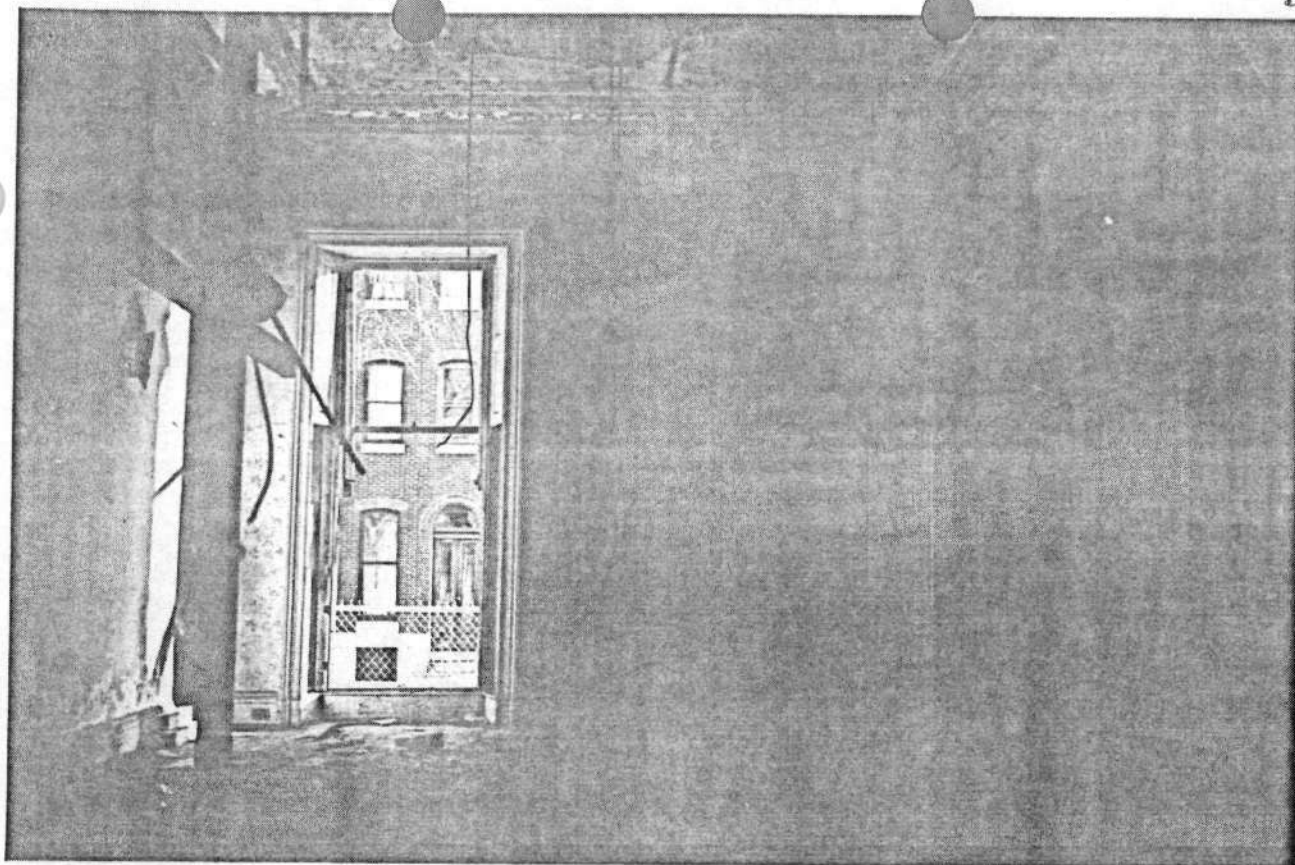
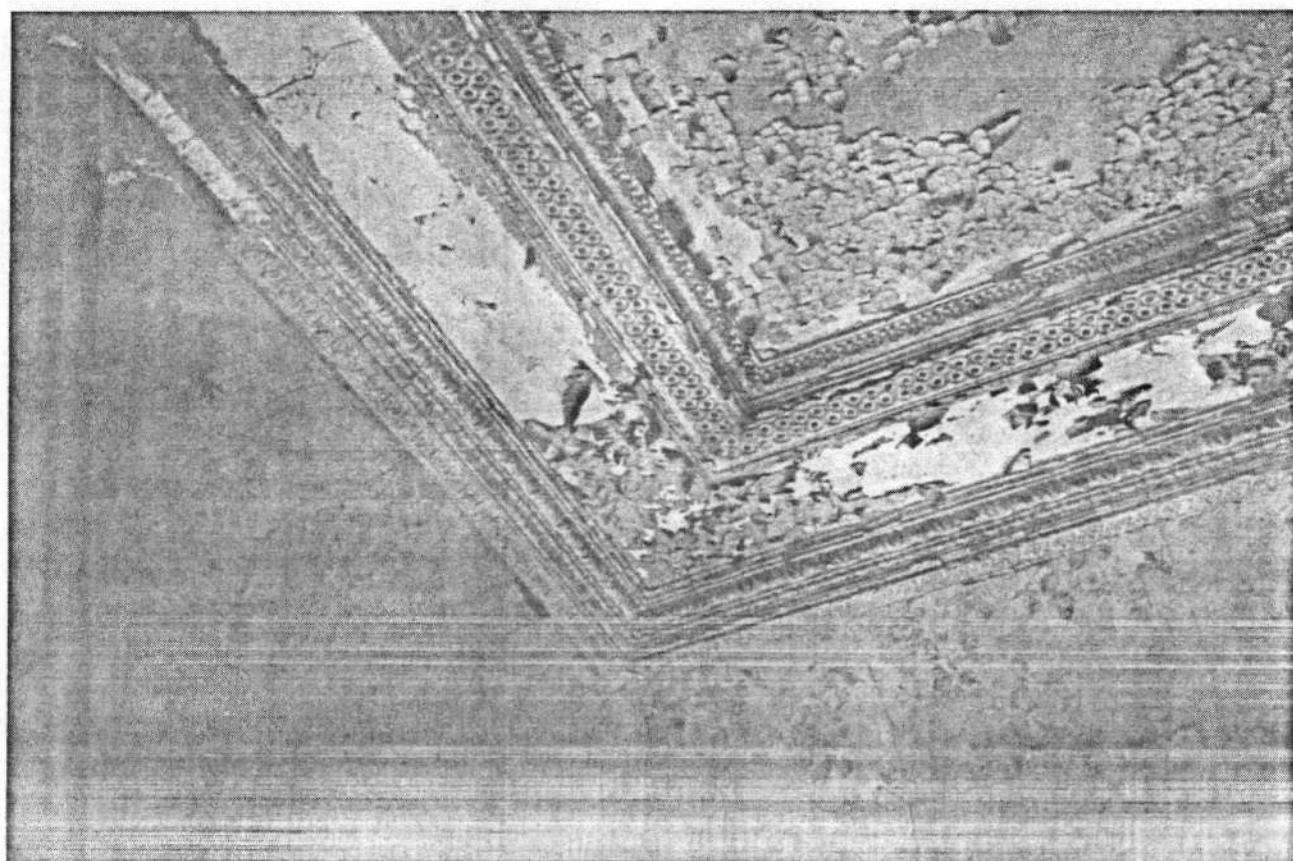
The front room, located off of the main hall, is in deteriorated condition, but still features some original molding and ornaments. The upper wall curves gracefully into the ceiling decoration. The outer rim of the ceiling molding includes dovetail and billet moldings and the inner ornamentation includes pellet and guilloche motifs. In the back of this room few remnants of fine detail work can be found; the ceiling and walls are unsound and the former passage into the next room is sealed with concrete.

17 12  
BANKARD/GUNTHER MANSION  
Baltimore City, Maryland  
Jeff Jerome  
December, 1979  
Commission for Historic and  
Architectural Preservation  
Front room, first floor with  
with entrance on west side

17 12  
BANKARD/GUNTHER MANSION  
Baltimore City, Maryland  
Jeff Jerome  
December, 1979  
Commission for Historic and  
Architectural Preservation  
Front room, first floor

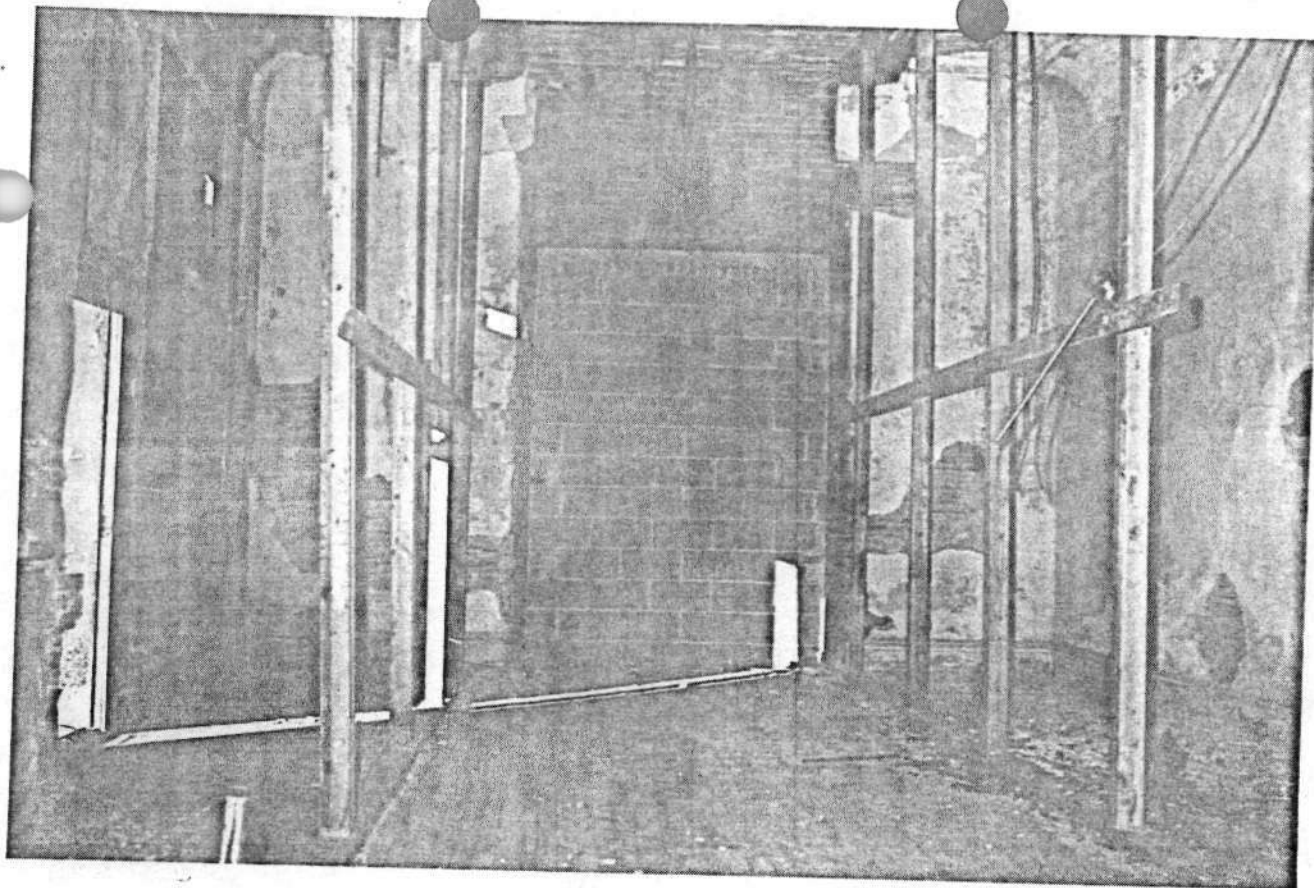
Access to the middle room is gained through the converted bay window on the west side. An oval shaped room in the curved section of the building, although in unsound condition, still features curved doors (one entering into a closet, the other into the hall) that round out the shape of the room. The large room with the bay window offers many fragments of the fine, early ornamental work. The wood molding

17 12  
BANKARD/GUNTHER MANSION  
Baltimore City, Maryland  
Jeff Jerome  
December, 1979  
Commission for Historic and  
Architectural Preservation  
Middle room with bay window  
(converted entrance)

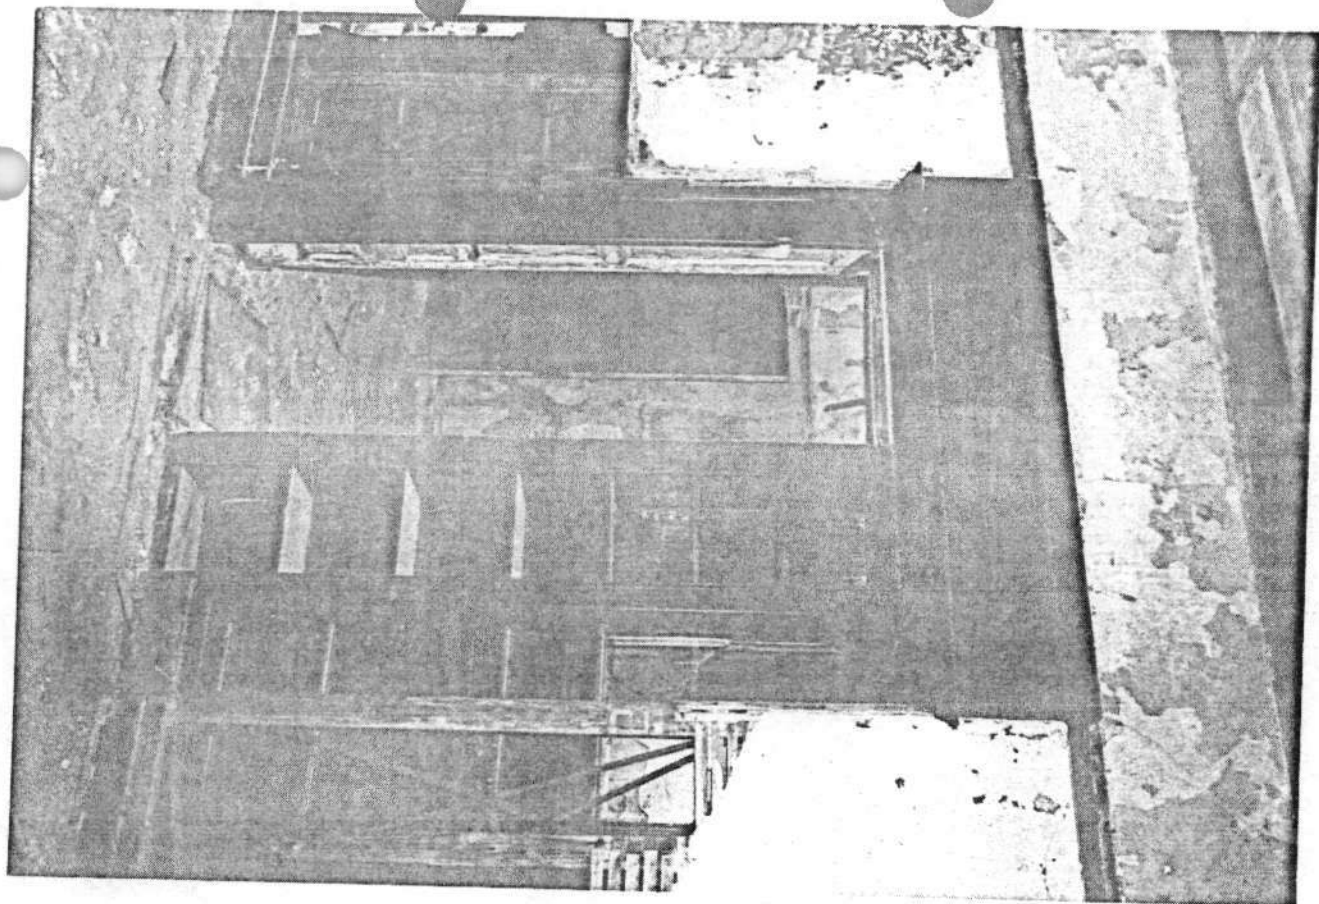
17 12  
BANKARD/GUNTHER MANSION  
Baltimore City, Maryland  
Jeff Jerome  
December, 1979  
Commission for Historic and  
Architectural Preservation  
Sliding doors and shelves on  
south side of middle room

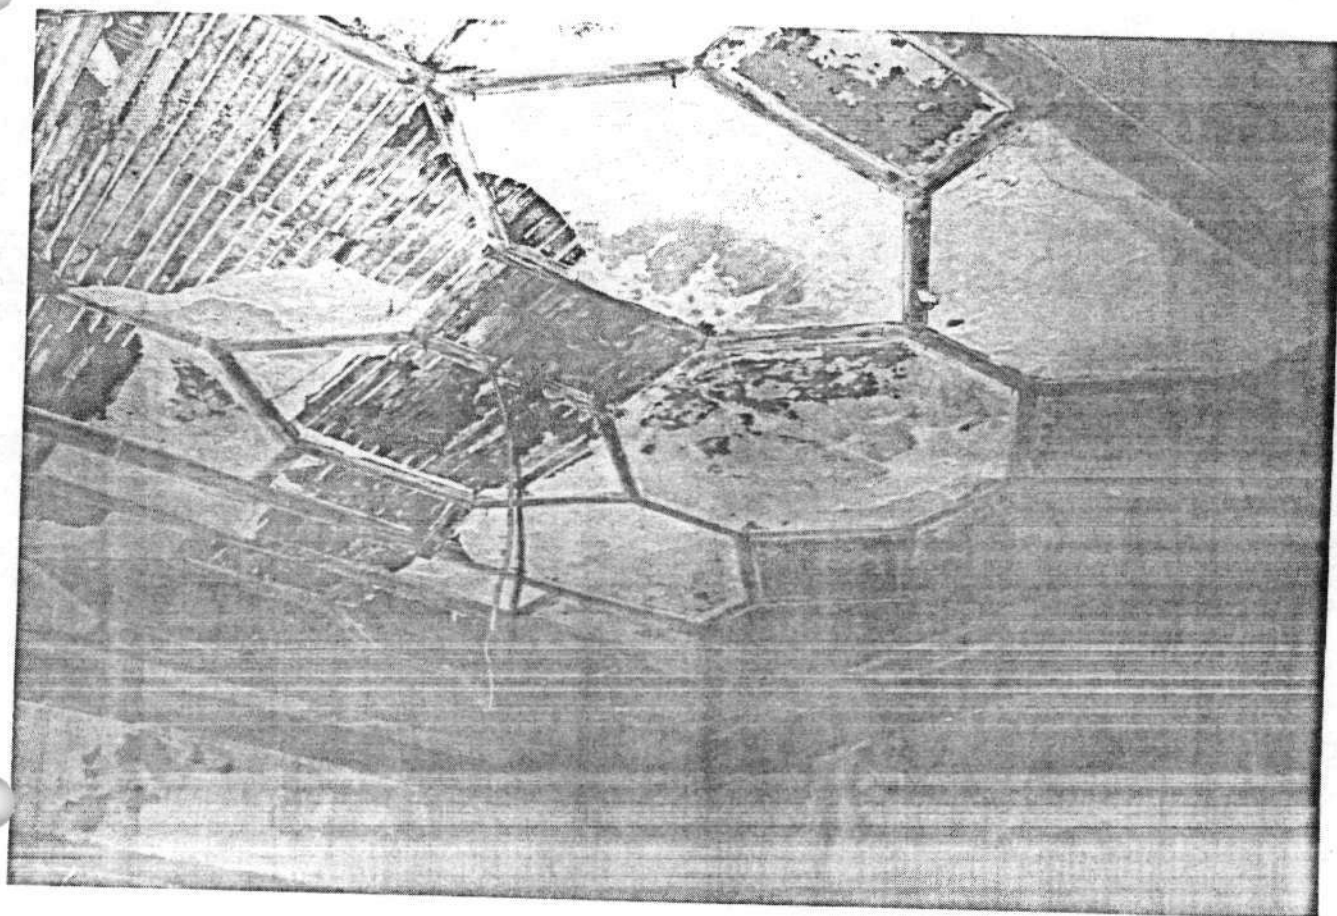
surrounding the bay window in is good condition and it, at one time, continued in a narrow band around the perimeter of the room. Sections of the handsomely designed, painted ceiling remain; a design consisting of large octagons, diamonds and lozenges at one time covered the entire surface. The south side of the room (towards the Baltimore Street facade) opens into the front parlor via sliding doors that house a wooden shelf; this construction remains in good condition. On the north side of the room is a fireplace and to its right is the armature of an earlier glazed structure. In all probability, this porch or greenhouse extended into a passage presently sealed behind the fireplace. It seems that this room was the most sumptuous to be found in the mansion.

BANKARD/GUNTHER MANSION  
Baltimore City, Maryland  
Jeff Jerome  
December, 1979  
Commission for Historic and  
Architectural Preservation  
Decorative ceiling, middle room  
of first floor
